Conversion, Vertical Extension, Seismic Retrofitting & Refurbishment

Residential and Commercial Buildings at Helvetiaplatz, Zurich

Molkenstrasse 15 & 17, Stauffacherstrasse 94 & 96

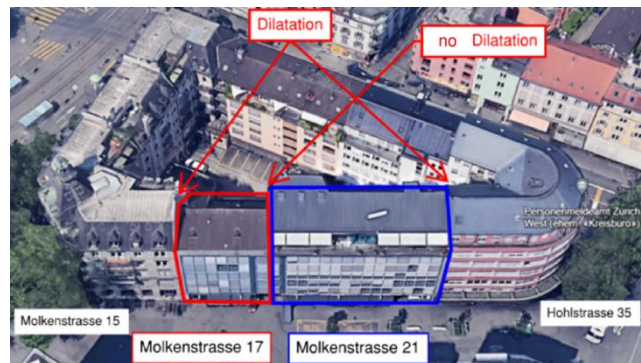
Since the part of the building at Molkenstrasse 17 is not dilated from the adjacent Molkenstrasse 21, the entire building mass was considered in the earthquake analysis. In consultation with the neighboring property owner, it was decided that the measures should be designed so that the earthquake strengthening of Molkenstrasse 21 is achieved with the measures in the Molkenstrasse 17 building. The cost-sharing was determined proportionally. The neighboring property was required to move out of the building.

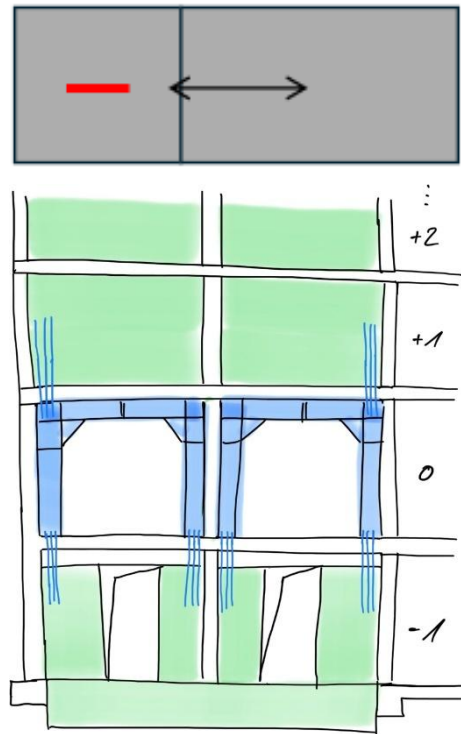
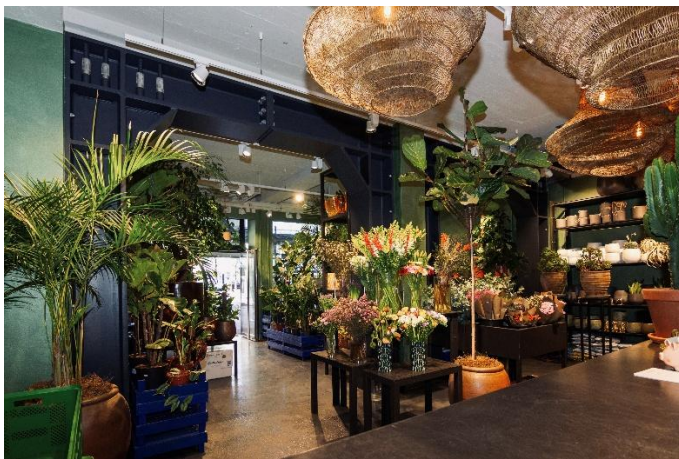
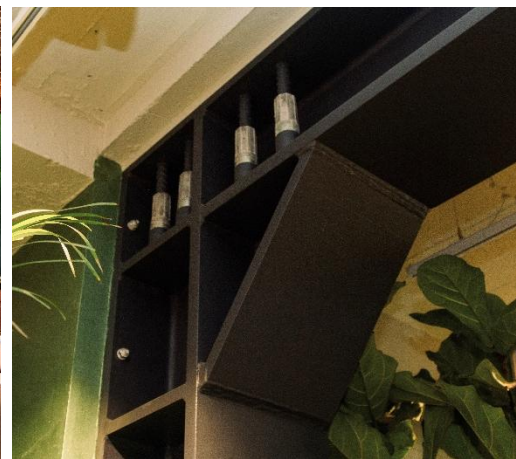
Due to the original skeletal construction, there was no existing **longitudinal bracing**, and a new system had to be developed from scratch. The schematic sketch on the right illustrates the structural concept. In the basement, a new massive strip foundation and earthquake walls were constructed, on which the new seismic axis was extended up to the attic. Two rigid steel frames made of HHD 400×287 S355 profiles enabled an open layout on the ground floor without significant loss of usable space for commercial purposes. The connection to the first floor was made using exposed threaded reinforcements (see photos). In the upper floors, the new apartment partition walls were designed as reinforced concrete shear walls.

A foundation system was developed that does not rely on piles. The reinforced concrete walls in the upper floors span across two bays. The tensile forces at the ends of the spans are transferred via threaded reinforcement into the outer columns of the two rigid steel frames. These outer columns are subject to both tension and compression forces during an earthquake, while the central column is loaded in compression only. This structural concept enabled the efficient design of the strip foundation as a two-span beam.

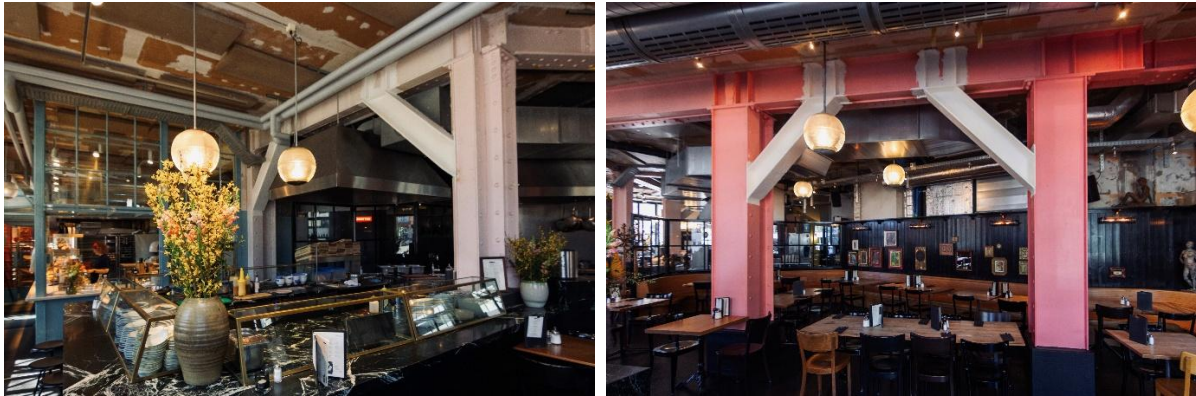
Residential and commercial buildings at Stauffacherstrasse 94 & 96 and Molkenstrasse 17 were constructed using masonry, steel, and timber. Due to this structural composition, their seismic behavior was analyzed using the push-over method. One of the key measures was to prevent so-called “soft-story” failure, making the bracing of the ground floor a primary focus.

For example, existing steel frames within the buildings were reinforced with new diagonal steel members. This intervention created rigid frame corners capable of effectively absorbing horizontal forces.

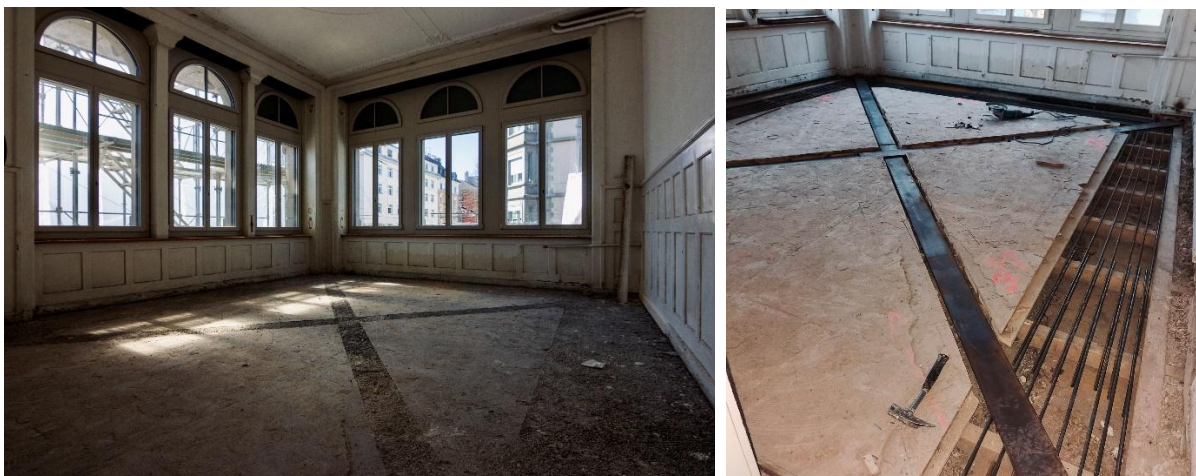
Furthermore, the ground floor slabs were structurally connected to the façade columns. In areas where reinforcement was only possible from below, steel angles were bolted to the façade columns and welded to the steel beams of the hollow-core slabs. This measure prevents buckling of the exterior columns or walls and ensures the structural integrity of the slab system.

In areas accessible from above, post-installed rebar was used along the slab edges to provide anchorage. Additionally, the slabs were upgraded into structural diaphragms by forming compression and tension zones in concrete and integrating diagonal tension elements made of steel strips:
